Quick inspection of secondary air valves

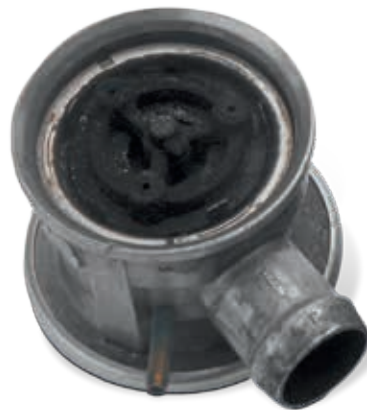
Damage as a result of exhaust gas condensate

In almost all cases this damage is caused by exhaust gas condensate in the secondary air pump.

In repairs, often only the secondary air pump is replaced.

However, the actual cause of the damage is not in the secondary air pump.

The trigger for this damage remains in the vehicle and can lead to the recurrent failure of the secondary air pump.

When replacing the secondary air pump, the electrical reversing valve and the secondary air valve must be inspected for leaks as a basic principle.

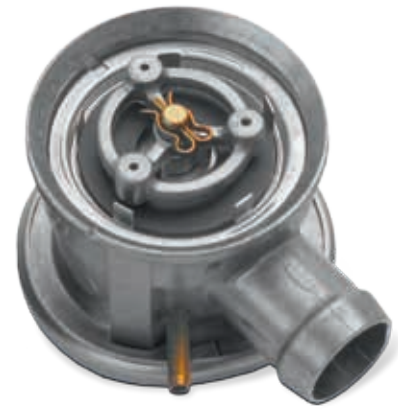
The new condition as a comparison

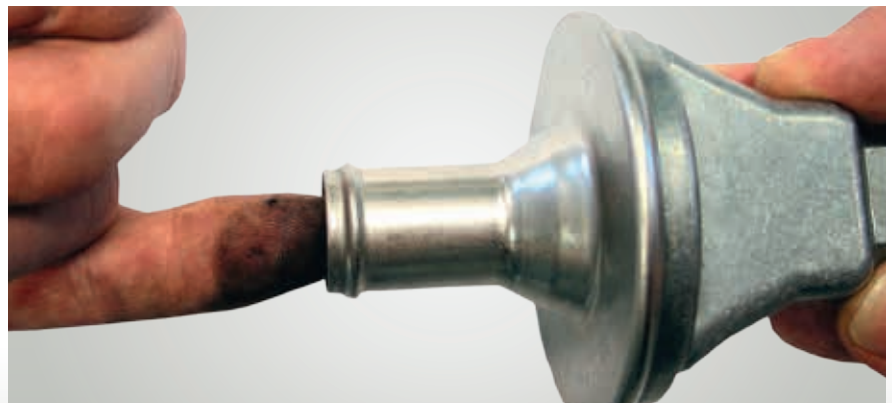
Fig. 1: Simple inspection of the non-return valve

- Loosen the connecting hose on the secondary air non-return valve leading to the secondary air pump.
→ See inspection point "P" on the graphic overleaf
- If there are deposits on this side of the valve (finger test, see → Fig. 1), the

nonreturn valve is leaky and must be replaced. In that case the secondary air pump may already have been damaged.

- Inspect the secondary air pump and replace it if necessary.

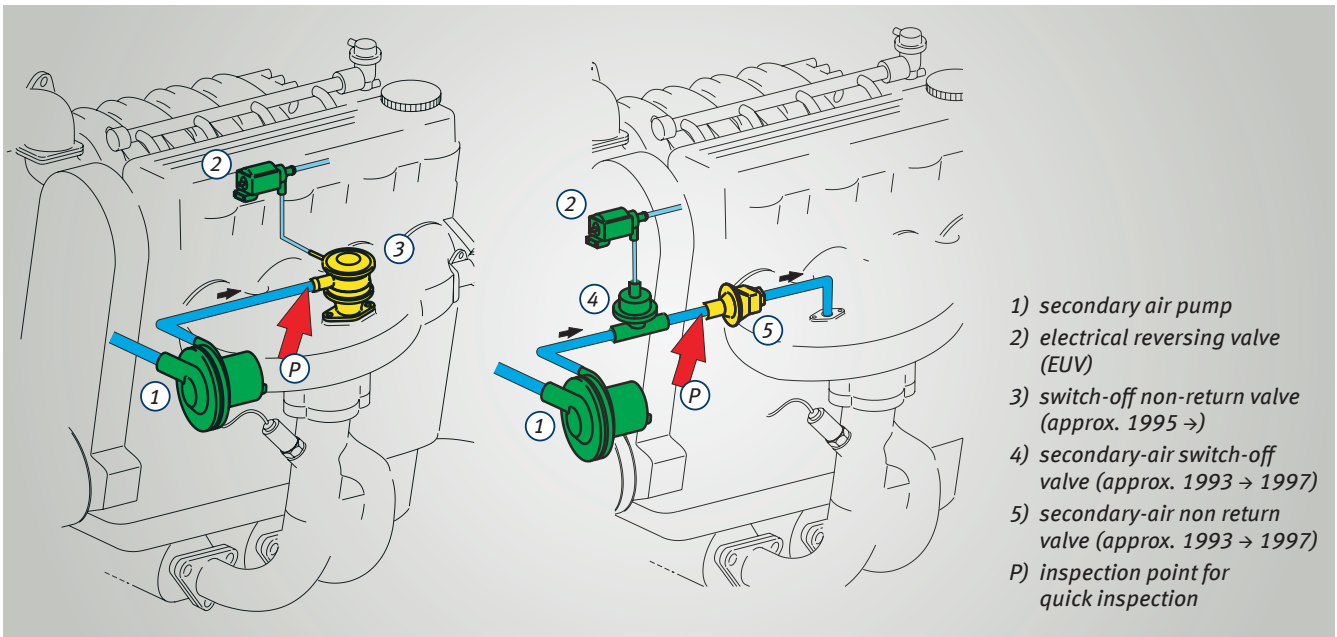
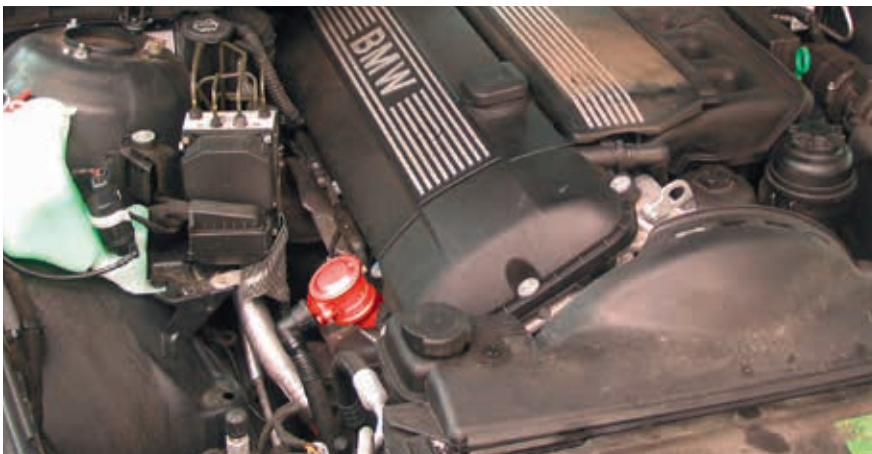
Two variants of the secondary air system

Secondary air valves are an integral part of the secondary air system. They are fitted between the secondary air pump (1) and exhaust manifold.

They prevent pressure peaks in the exhaust flow from damaging the secondary air system and exhaust gas or condensate from entering the secondary air pump.

There are different designs of secondary air valves:

Switch-off non-return valves (3) are generally vacuum-operated valves. Later designs (from approx. 1998 to date) are opened by the pressure of the secondary air. This does away with pneumatic control by an electrical reversing valve (2). Secondary-air non-return valves (5) open as a result of the pressure of the secondary airflow.

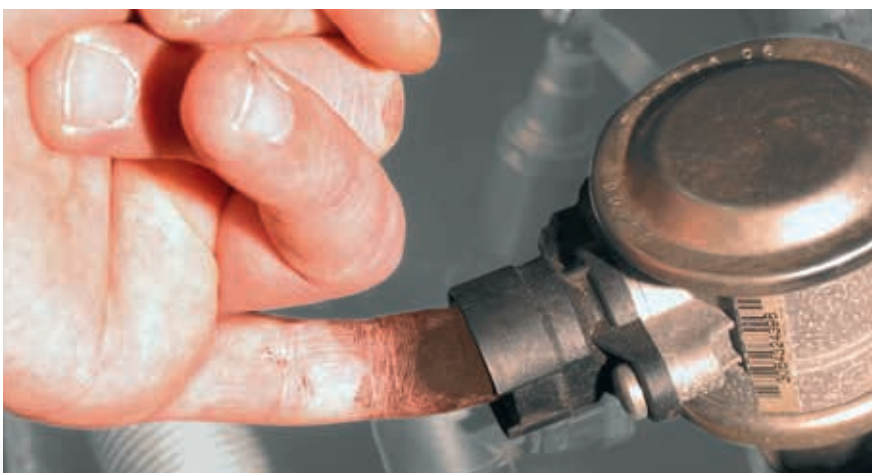
Schnellprüfung am Sekundärluftventil im BMW 520i (hervorgehoben)
